# **Human Resources Building**

## **Condition survey**

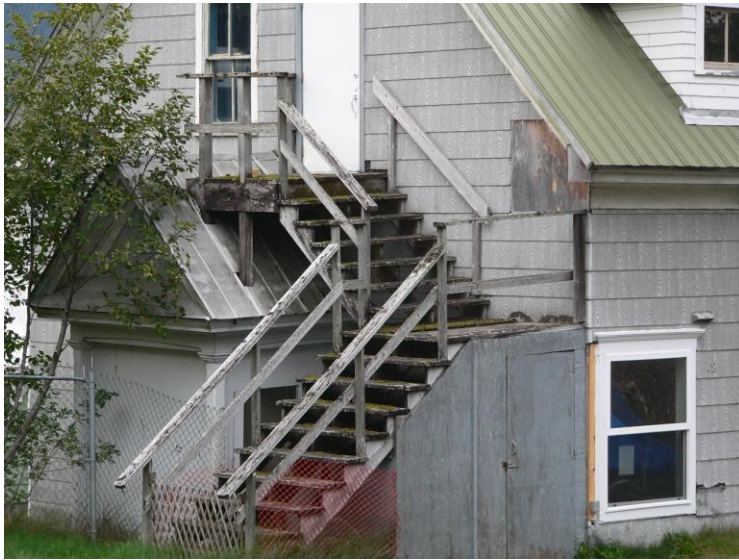
There is an exterior landing on the second floor, on north end of building constructed from standard non-treated, material. Landing and stairs were in very poor condition . Repairs were made see picture below.

Rotted landing and stairs and hand railing.

**5. Landing and stairs:** The landing and the stairs on the north end of building is in a stage of decomposition and is unsafe and unusable .also the covered porch below landing should be torn down.

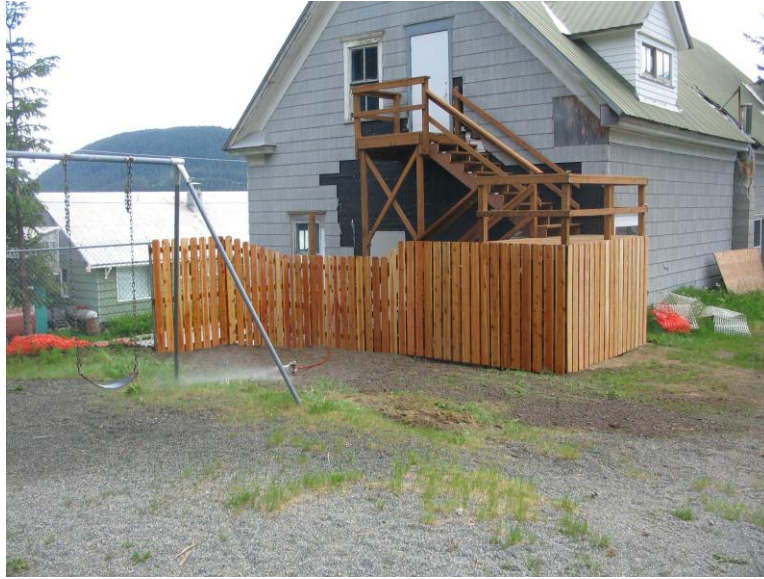
New stairs .

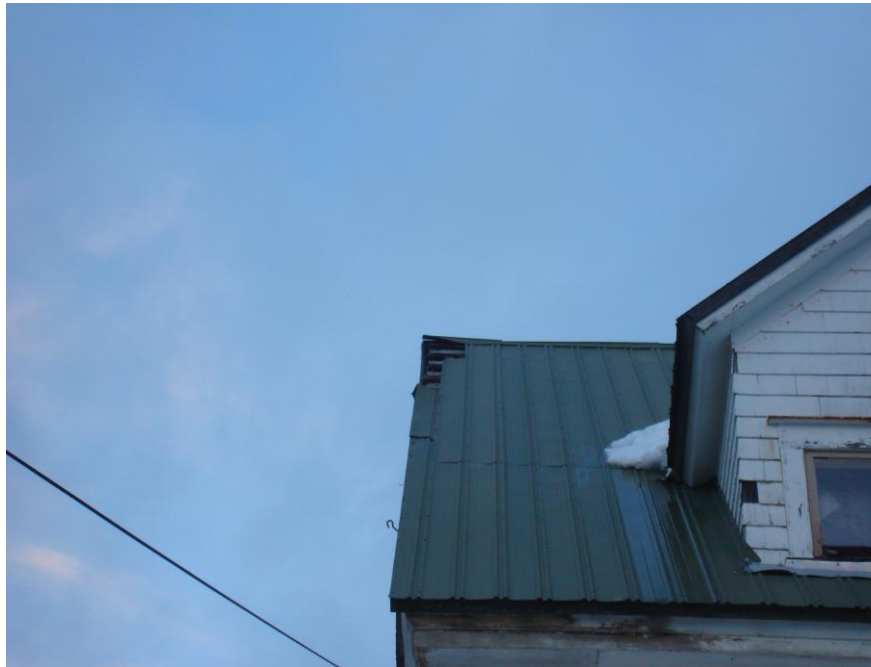
**Roofing:** The original roofing was cedar shakes and was covered over at a later date with metal. And around 1976 that metal roof was then again obscured by another layer of aluminum roofing which is in very poor condition. *The roofing needs to be replaced ASAP.*

30 year old aluminum roofing wind damage.

**3 Roofing:** The roofing and Chimney repair should be done ASAP *See bid proposal.*

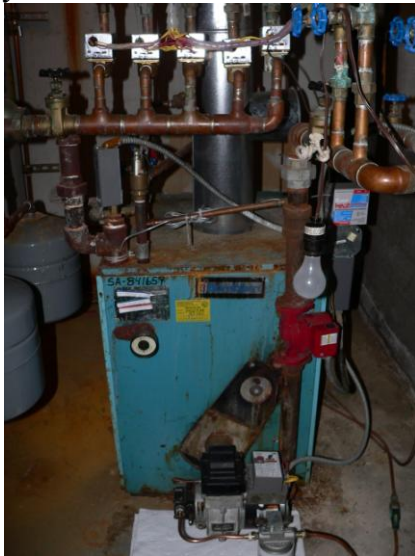
Water is heated via a 30 year old Burnham oil fired boiler. The hot water is circulated through 5 separate zones including 1 zone for a unit heater in basement. There is only one circulating pump for heating system. The hot water is carried to the first and second floor and distributed as baseboard heat. The fuel for the burner is stored in a 500 gallon tank at the north end of building, pumped in through a single pipe system. Condition of boiler and boiler related piping is fair, at the time of this survey the masonry chimney had been demolished by the snow sliding from roof. The new flue will follow a chase up through the middle of building. *The reliability of the boiler has been fair, but due to its age and inefficiency it should be replaced within the next 1-3 years.*

Old Burnham boiler.

**4. Heating:** Replace 30 year old boiler with newer more efficient unit.

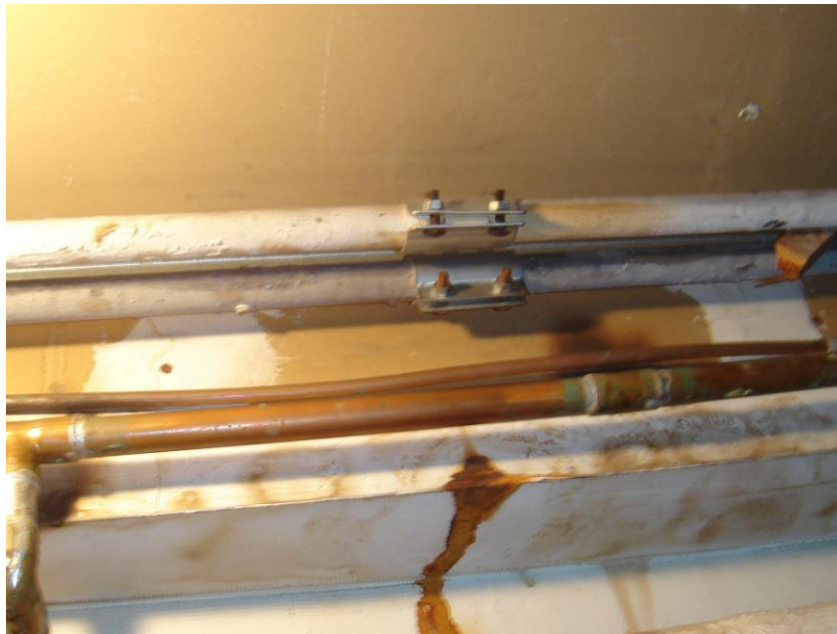
The domestic water enters the Human Resources Building in basement, at the north end of building. There is no outside water shutoff. Water piping is iron and soldered copper. Most piping is in very poor condition with evidence of leaks and repairs.

Repairs hot and cold.

**5. Water:** Replace corroded domestic hot and cold water piping system

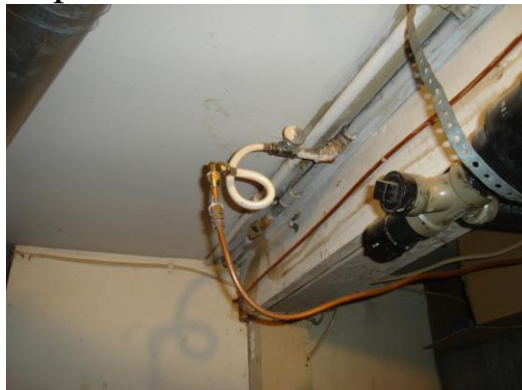
Cold water to kitchen.
